**M. S. Cross describes
some pre-grouping
rail built
buffer stops**

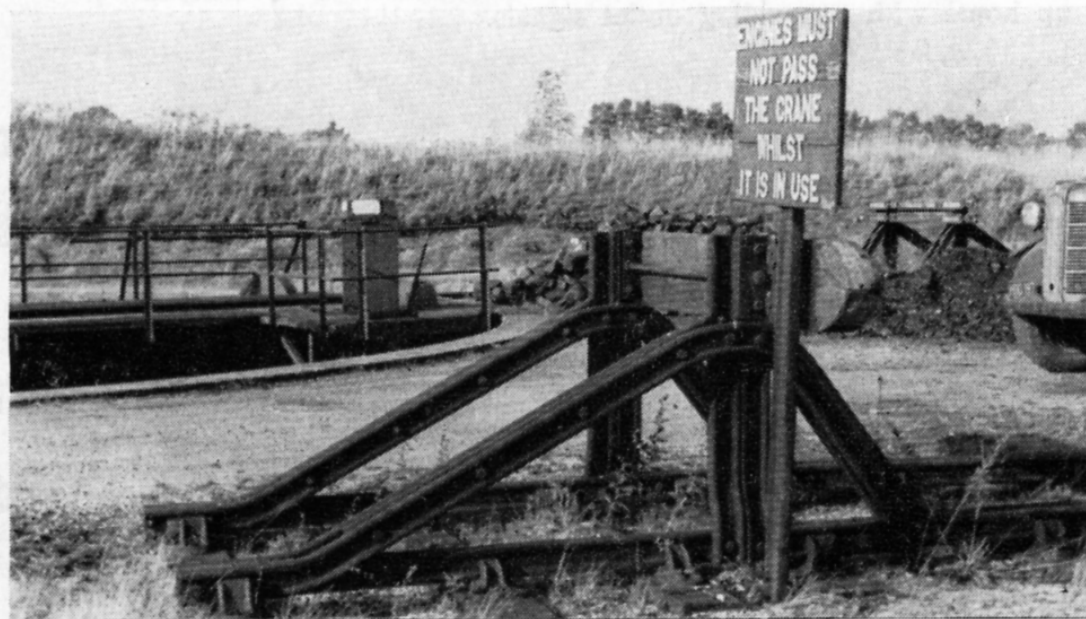
1: GWR

This neat, simple structure appears to be a standard type. The prototype was measured at Kidlington, but the photograph was taken at Fairford. Note the rounded beam in the latter and the fishplates where the tie rod enters the uprights. There is a central rail in the compression strut, which is bent to join the uprights at the top end. The uprights are joggled so as to rest flush with the outside faces of the running rails, to which they are bolted. The extension of the inner tension strut is joggled to provide a flangeway and special chairs are used to accommodate the groups of rails. At Fairford, ancient inside-keyed chairs have been utilised, a relic of the days when the entire line was so constructed.

1: Great Western

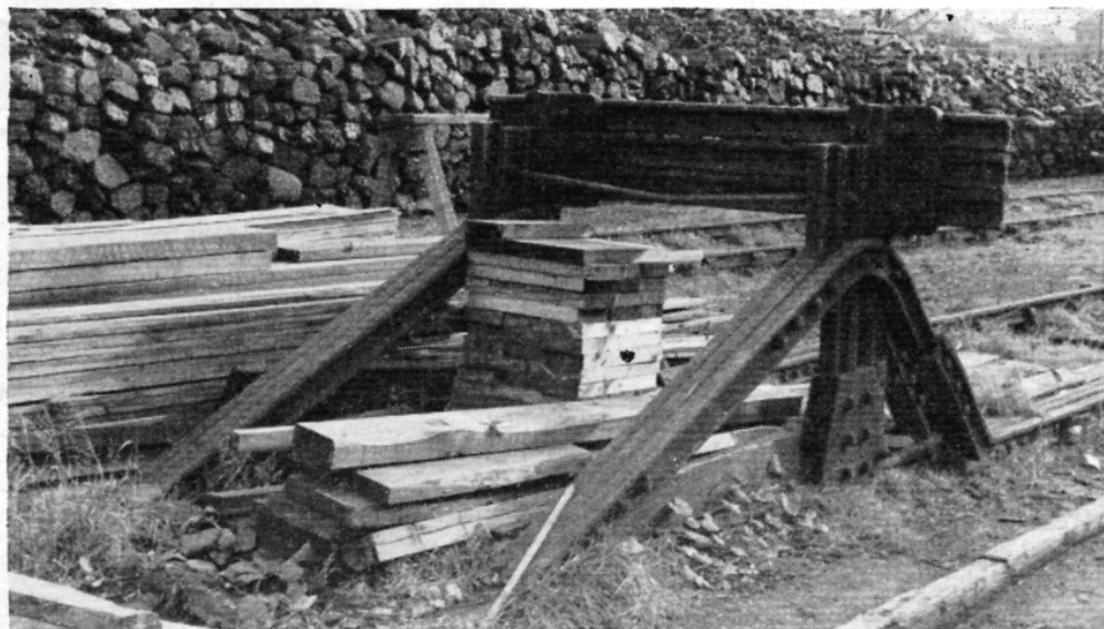
2: GCR

A very substantial structure. The three-rail beam is bolted through fishplates to a special chair, which is fitted to the leading upright rail. These chairs appear to be special rail-joint chairs left over from some experiments in this direction during the Victorian era. Other interesting features are the wrapped running rail ends, the use of extra tension struts and the long spacer in the flangeway. The photograph and measurements were taken from a prototype at Rugby Central.

2: Great Central

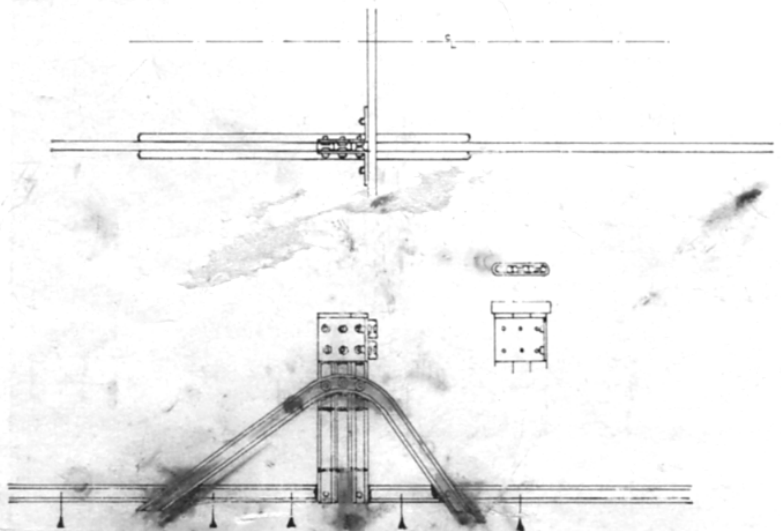
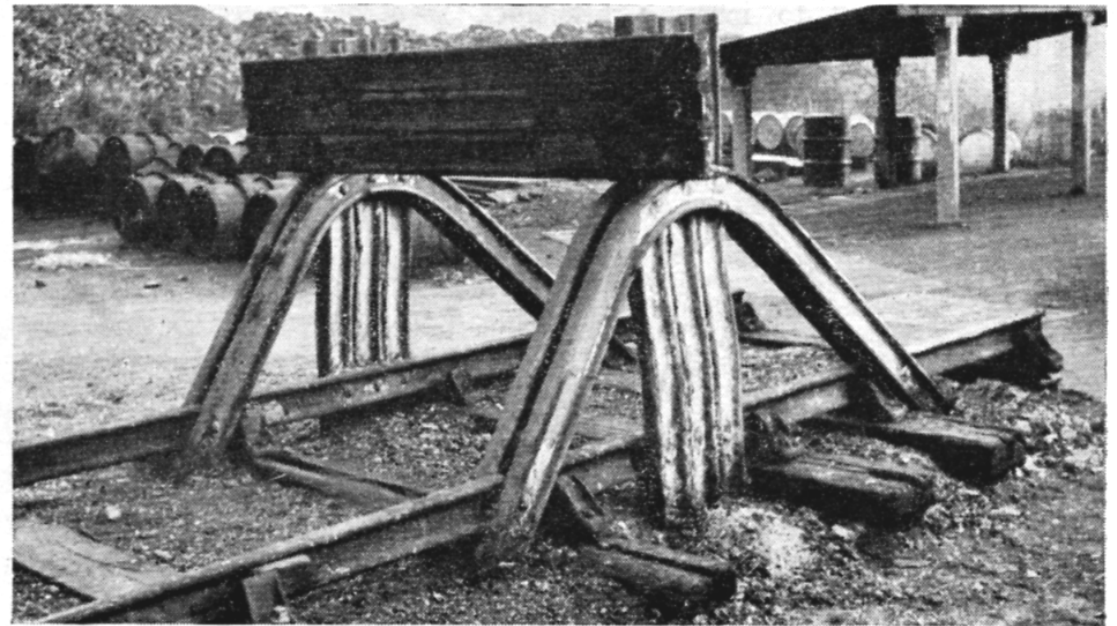
5: MR

A very simple structure this; two or three buffer beam rails are bolted to the uprights by angle plates. The uprights are gently joggled to lie flush with the outside of the running rails. From observations at March, the Great Eastern appear to have used a very similar type of buffer stop, the difference being a metal collar round the top of the uprights. This is shown on the drawing. The photograph was taken at St. Albans Loco Depot; note the inside-keys of the chairs.

5: Midland
